# BLAST FURNACE GAS LEAK PIPE REPAIR

ID: 7814

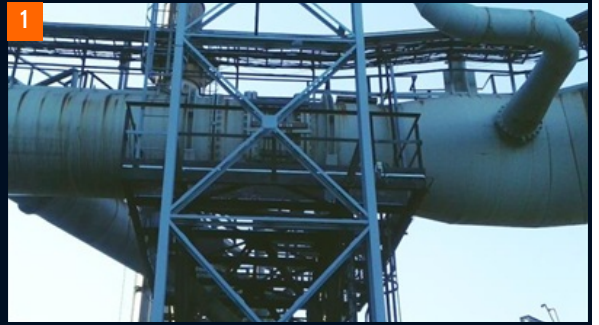
Steel plant blast furnace gas inlet had developed a leak and was losing pressure. The repair needed to be done whilst equipment was online.

The blast furnace gas inlet.

The gas leak was causing a risk of explosion, so Belzona 1211 was used to initially seal the crack and stem the flow of gas. Once the leak was stopped, the necessary surface preparation was carried out with a grinder so that a stronger reinforcement of Belzona 1111 and Belzona 9341 reinforcement mesh could be applied to the pipe to provide a long-term reinforcement to the damaged area.

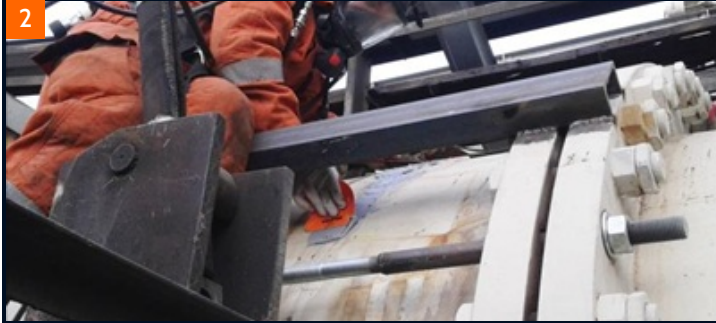
The repair is underway.

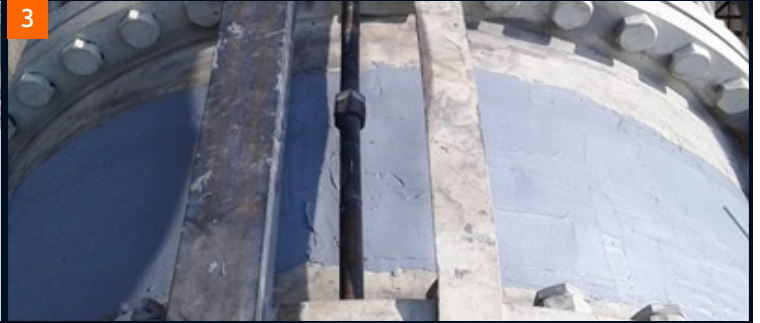
The finished repair.
