# BELZONA REPAIRS AND PROTECTS A SAND FILTER IN A SWIMMING POOL

ID: 7815

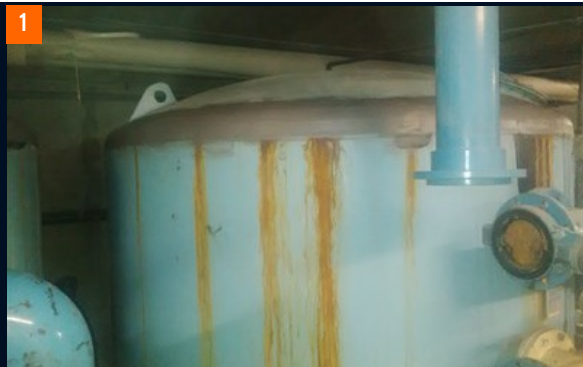
The inside of this sand filter in a swimming pool was badly damaged by corrosion and chemical attacks, especially chloride. After grit blasting the substrate, through-wall defects were found.

Before application.

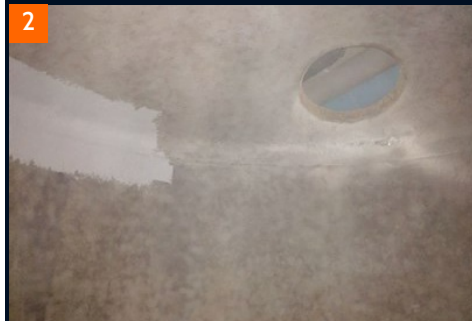
Repair using Belzona 1111.

The substrate was first prepared by grit blasting, then the pitting was repaired with Belzona 1111. On top of this repair, Belzona SuperWrap reinforcement sheets impregnated with Belzona 1981 resin were applied to restore the structural strength of the filter. Finally, Belzona 5811 was applied on the whole surface inside the tank after a surface preparation of the Belzona SuperWrap using an MBX.

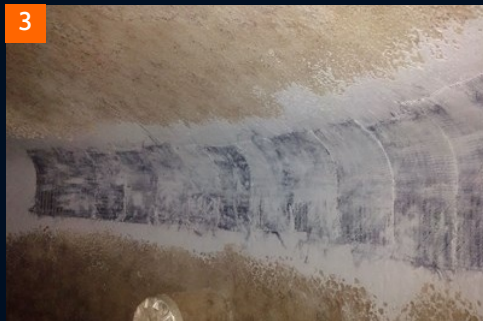
Application after using Belzona SuperWrap II.

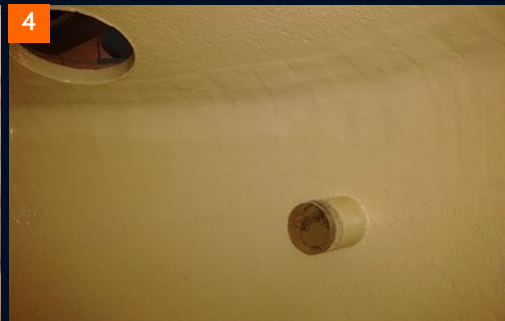
Final application.
