# BELZONA REBUILDS AND PROTECTS A CLARIFIER

ID: 7816

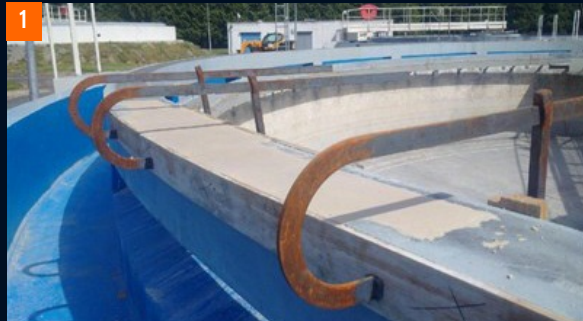
Concrete repair on the roller track with Belzona 4111 and a former.

The broken parts of concrete on the roller track were taken away and the surface of both the track and the clarifier trough were prepared by scarification. Metal components were prepared by grit blasting. After the surface preparation, the concrete was rebuilt using Belzona 4111 with a trowel and a former when needed, in accordance with a modified version of Belzona Know-How System Leaflet TCC-09. The trough next to the roller track was protected with Belzona 5111. The floats and turbines were protected with Belzona 5811.

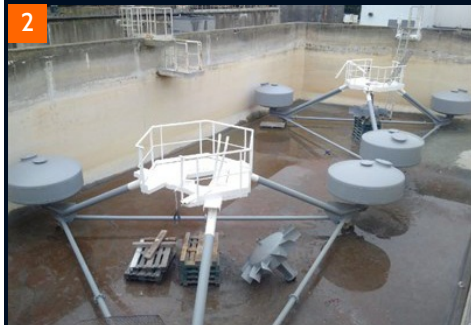
Protection of the tripods, turbines and floats with Belzona 5811.

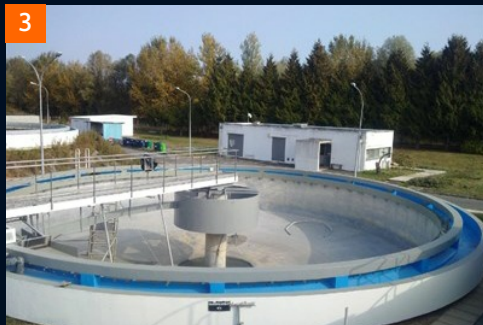
Final application.

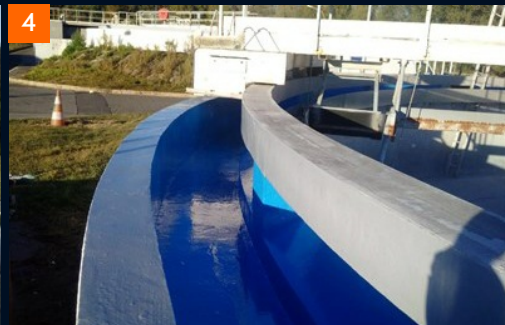
Close up view of final application.
