# BELZONA REPAIRS COOLING WATER PIPE AT A STEEL PLANT

ID: 7818

Steel plant cooling water pipe.

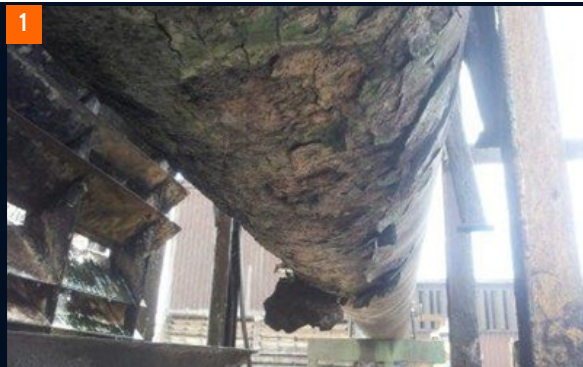
Corrosion had caused heavy damage on cooling water pipe, therefore weakening the jacket. This may have eventually led to a through-wall defect which would cause a costly downtime period.

The original corroded pipework

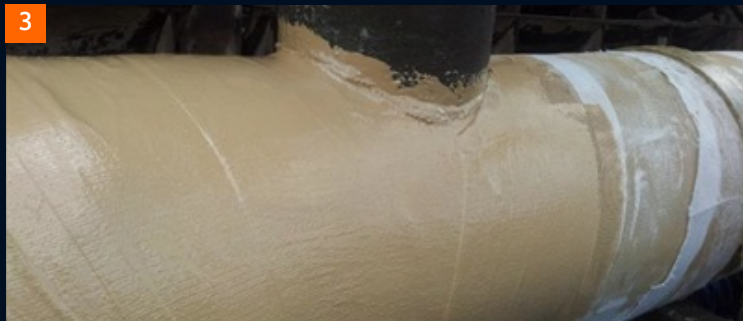
Belzona 5811 reinforcement

After removing the impurities, the pipeline was treated with the Belzona 5831 coating system. Subsequently, the areas were pressed with Belzona 1111 and reinforced with reinforcing sheets. At the end, the entire pipe casing was treated with a two-component coating system for a long-term protection of Belzona 5811 in combination with Belzona 9341 reinforcement tape.
