# INTERNAL REPAIR AND PROTECTION OF A SPLIT CASE PUMP WITH BELZONA 1341

ID: 7819

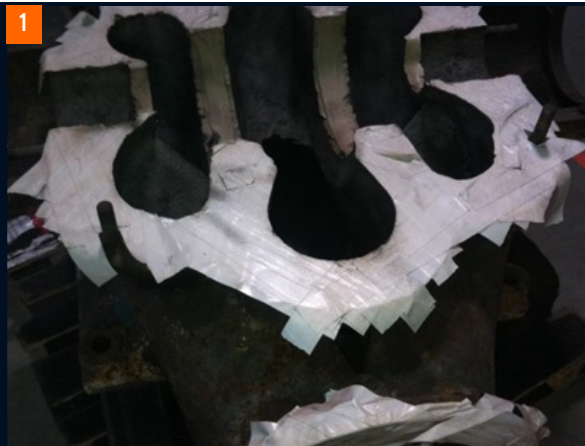
The internal surface of this splitting-case pump was badly damaged by corrosion and needed to be rebuilt and protected.

Before the application

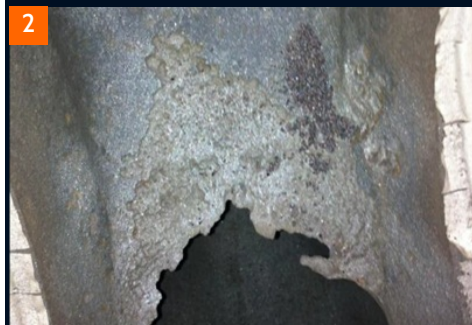
Showing the damage on the internal part of the pump

The substrate was first grit blasted and cleaned with acetone. Then the displacement nose was rebuilt using Belzona 1111. Finally, the whole internal surface was protected with 2 coats of Belzona 1341. The application was carried out in accordance with Belzona system leaflet CEP-3.

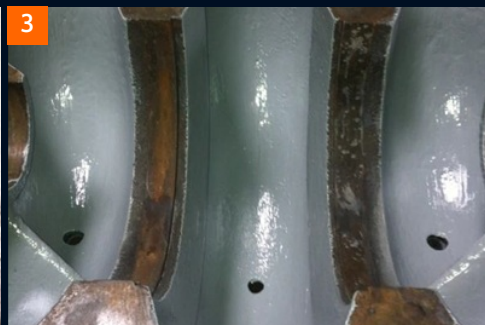
First coat of Belzona 1341 in grey

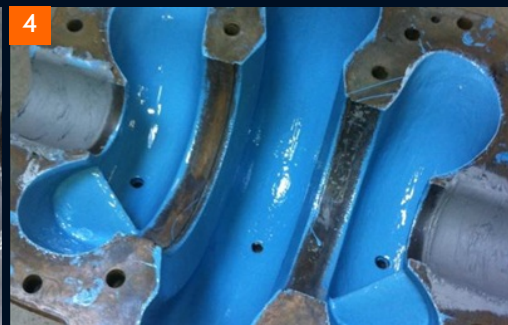
Second coat of Belzona 1341 in blue

The advantage of the system is that a possible wear of the coating would be easily identified thanks to the 2 different colours used (grey and blue). Besides, the smoothness of the coating can also increase the pump efficiency.
