# NO MORE LEAKS ON A COOLING TOWER WITH BELZONA

ID: 7820

Water pipe on a cooling tower.

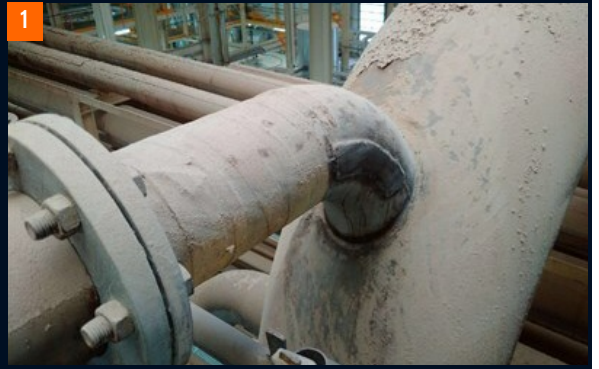
This water pipe was leaking due to antibacterial agents present in the water damaging the substrate and causing corrosion pitting.

Before application

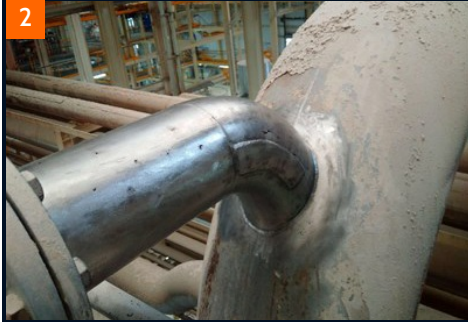
After surface preparation

The pipe was manually prepared using an MBX and degreased with Belzona 9111. The pipe was then consolidated using Belzona 1111 and 9341 (3 passes). Belzona 1321 was finally used on top of the repair to avoid any porosity and give a good smooth finish.

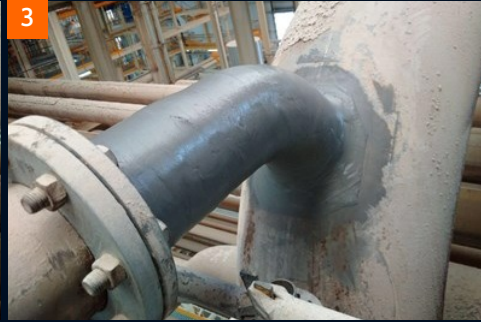
After application of Belzona 1111 with reinforcement tape

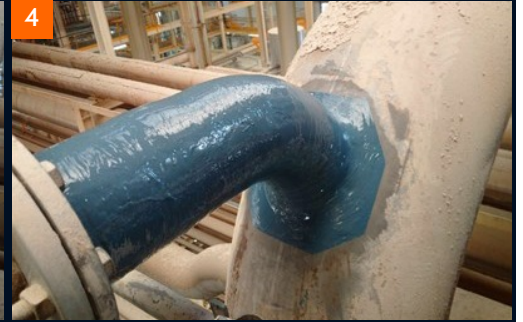
Final application

The customer tried a different alternative on this pipe but it lasted for less than 2 months. Replacing the pipe would have been really expensive and would require the purge of the whole system. This solution was quick and really efficient. After 2 years in service, the repair is still intact.
