# PAPER MILL PRESS ROLL SAVED FROM REPLACEMENT BY BELZONA

ID: 7823

Solids Handling Machinery - paper mill press roll.

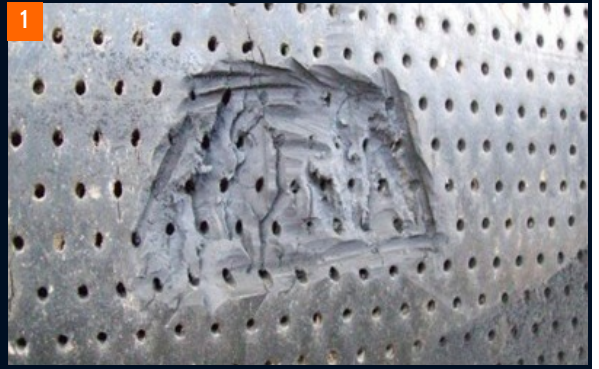
Trapped material under the press roll caused scoring damage to the surface.

Damage to the roller.

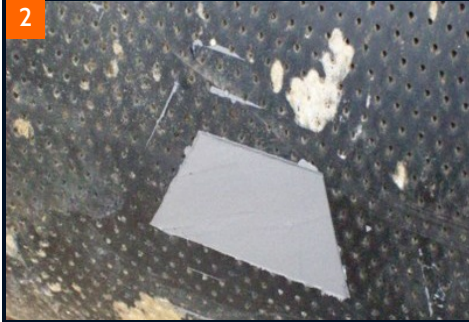
Belzona used to rebuild the surface.

Belzona 1111 (Super Metal)

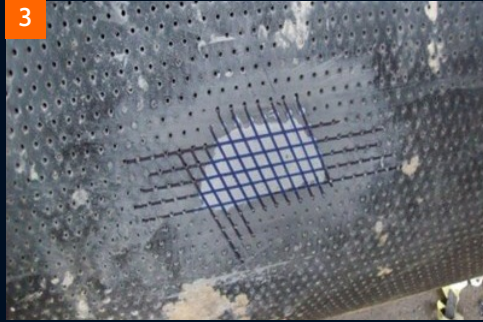
Mark up of areas to be drilled.

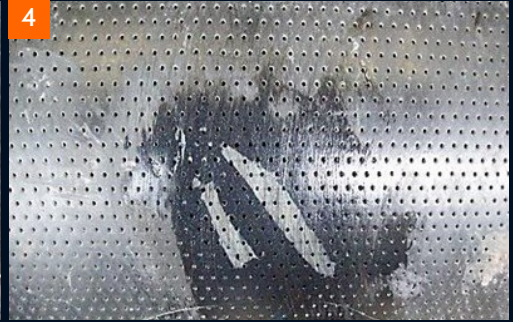
Completed application.
