# WOOD PARTICLES DRUM REPAIRED WITH BELZONA

ID: 7824

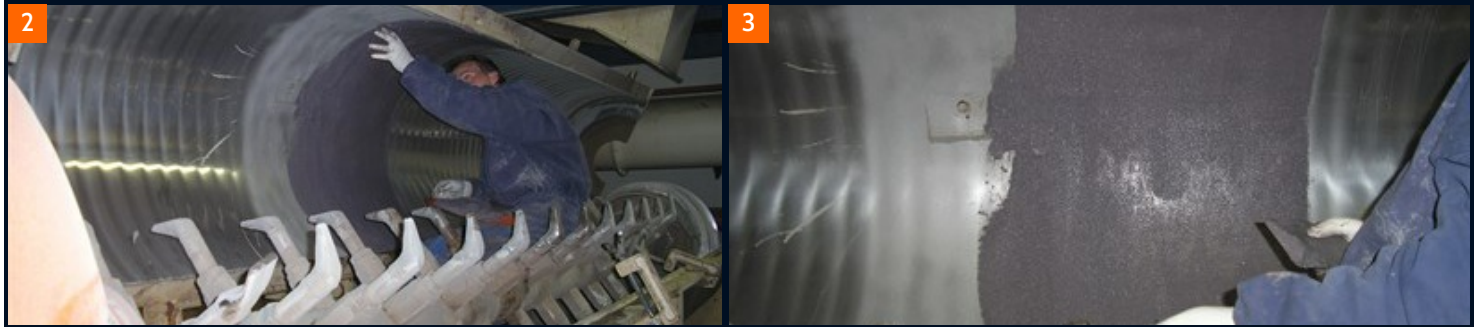
## PHOTOS

The glue and wood particles mixture was very abrasive and the after a short period of time, there was localised damage to the drum.

1. Surface after blasting - ready for repair
2. Belzona 1812 local application
3. Perfect protection against abrasive mixture

The only alternative to the Belzona solution was to replace all of the drums with new ones, as welding was difficult and time consuming. Also, replacing would have been very expensive and time consuming. The Belzona solution solved these problems that the customer had faced.
