# PIPE ADAPTER REPAIRED BY BELZONA

ID: 7825

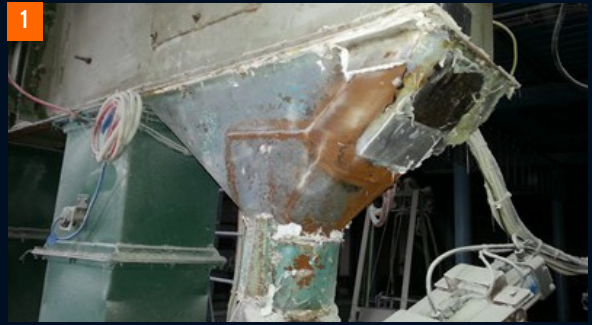
1. Pipe system for maize kernels transportation
2. Pipe adaptor in system
3. Perfect protection against abrasive maize kernels
4. Detail of the finished repair

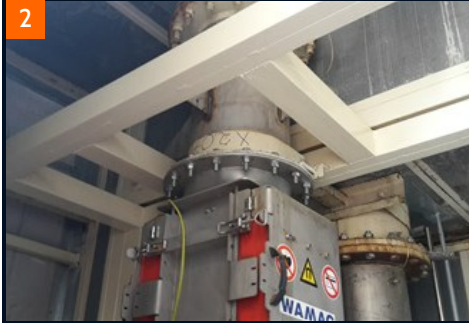
Maize kernels transport is very abrasive. This product is able to damage some parts of the pipe system in 6 months.
