# ROLLER SHAFT RE-BUILT WITH BELZONA

ID: 7826

## PROBLEM

The 400mm shaft for the roller in this steel mill had become damaged and developed 6mm of headspace inside the bearing, and therefore needed reprofiling.

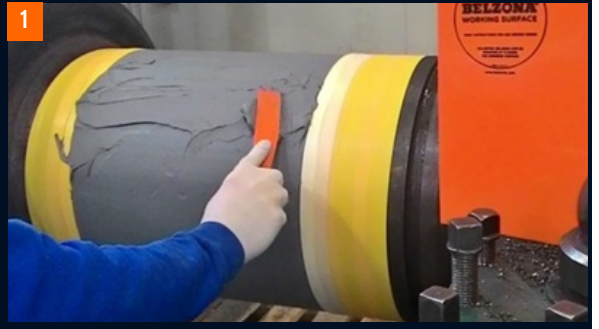
Belzona 1111 used to build the profile up.

The prepared surface was cleaned using Belzona 9111. The profile was rebuilt with Belzona 1111, then machined back to the correct diameter using a lathe.

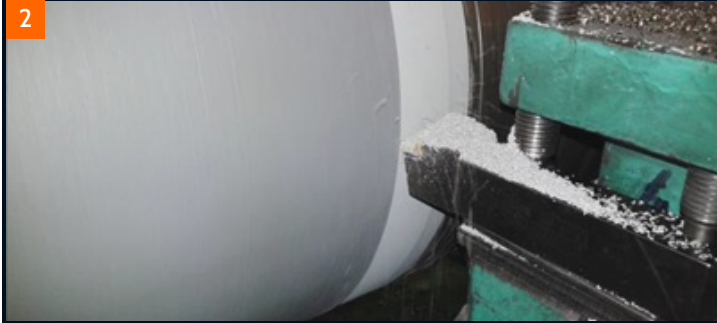
The Belzona being machined back on the lathe.

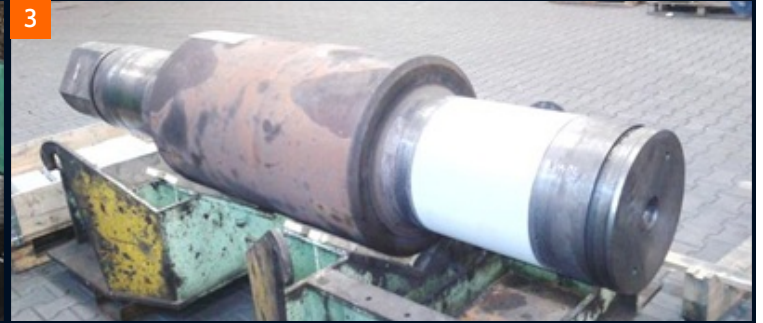
The completed repair.
