# BELZONA SHAFT REPAIR BY FORMING TECHNIQUE AT A PAPER MILL

ID: 7835

Shaft on a vacuum pump at a paper mill.

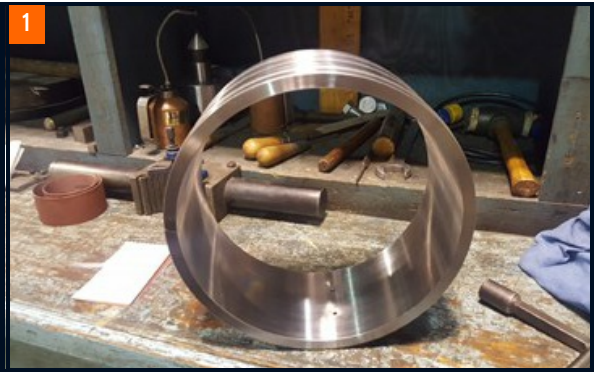
Former that was made and used.  
Damaged shaft.  
Shaft prepared/surface roughened up.  
Finished application.

This application was carried out in accordance with a modified version of Belzona Know-How System Leaflet MPT-2 (Shaft Repair by Forming Technique). The area was prepared by using a small disk grinder which was used to cut grooves into the shaft then was roughened by using a bur bit. The shaft was thoroughly cleaned using Belzona 9111. Belzona 9411 was placed on the former and on the shaft where product was not wanted. Belzona 1111 was placed on the shaft and on the former and squeezed together. After a few hours the former was removed and the shaft was dressed up making sure to remove any unwanted Belzona 1111.

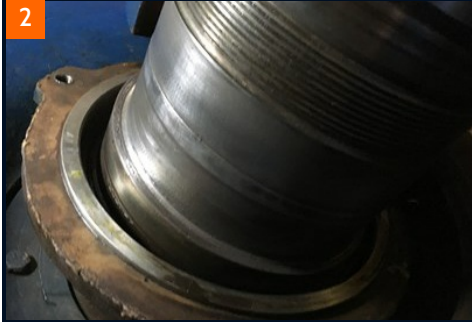
Bearings spun on shaft taking with it an estimated .080 or 80 thousandths from the shaft.
