# BELZONA PROTECTS PULP BEATER

ID: 784

Erosion corrosion wear on body and cover caused by paper pulp.

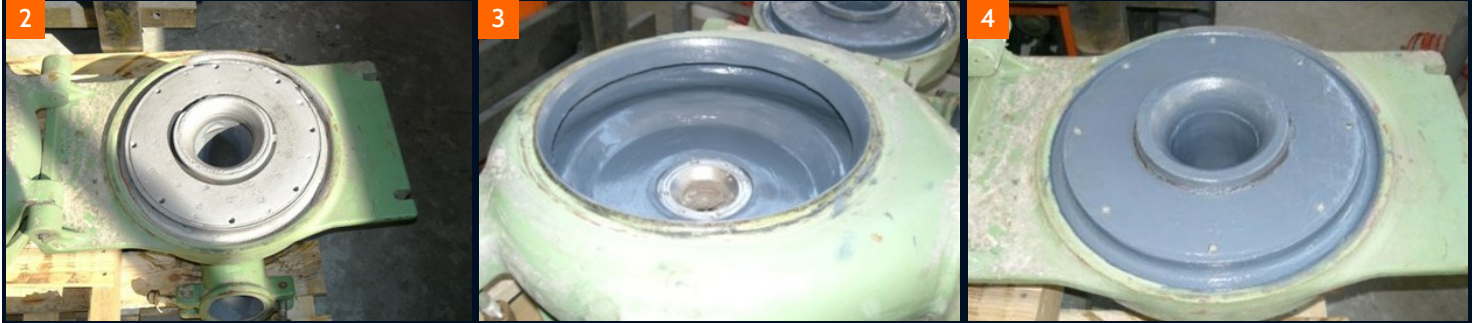
1. Inside the beater after blasting.  
Remaining Belzona still evident.
2. Cover after grit blasting.
3. Body and cover coated with Belzona.
4. Beater cover after application.

The application was carried out in accordance with Belzona Know-How System Leaflets CEP-3 and CEP-5.

The equipment had previously been coated in 2000 and this application was to renew the eroded coating. Replacement of Belzona cost a fraction of replacement unit.
