# BELZONA HIGH TEMPERATURE RESISTANT COATING PROTECTS TRANSITION SPOOLS AND VESSEL

ID: 7850

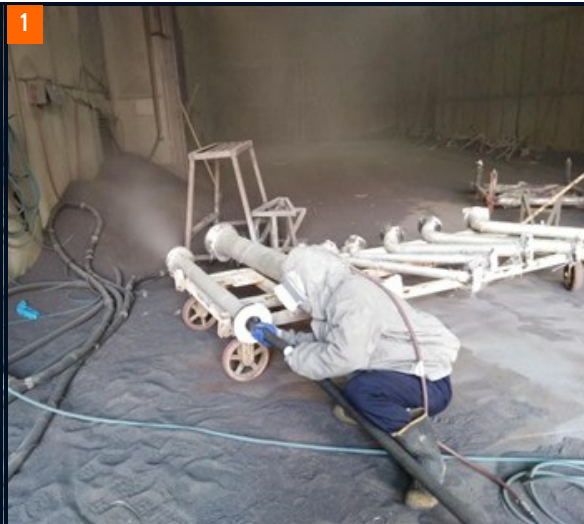
Grit blasting in progress.

The application was carried out in accordance with Belzona Know-How System Leaflet VPF-3. Following surface preparation by grit blasting, the Belzona 1391T was hand applied directly onto the prepared surface.

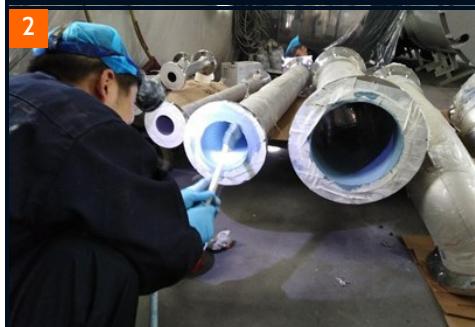
1st coat applied.

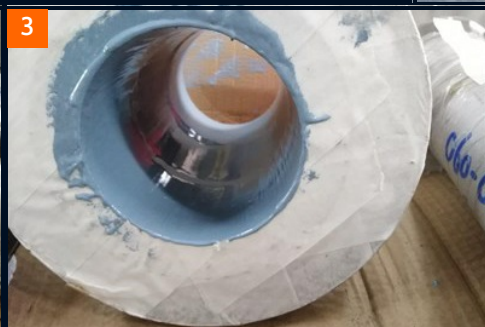
2nd coat completed.

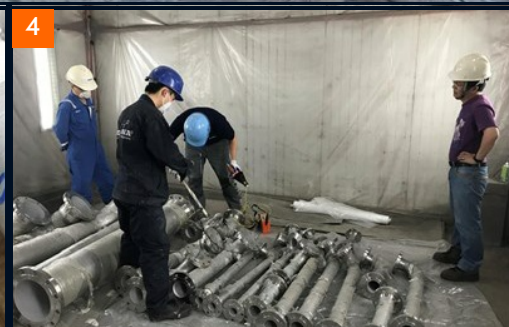
HVT testing.
