# BELZONA ELASTOMER SOLUTION FILTERS OUT THE COMPETITION

ID: 7853

15-year-old limestone filter at a power plant.

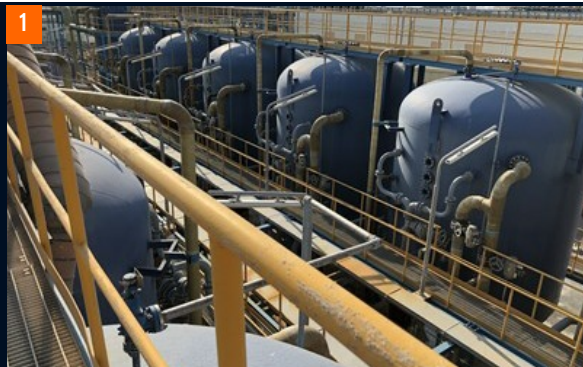
Limestone filters at the Power Plant.

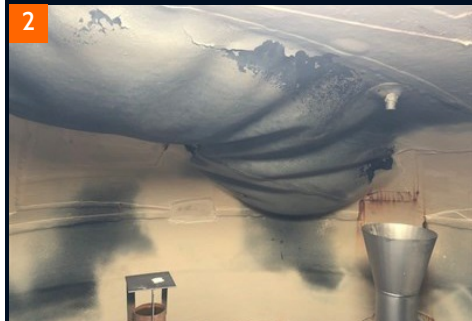
Alternative rubber lining disbonded during a trial phase.

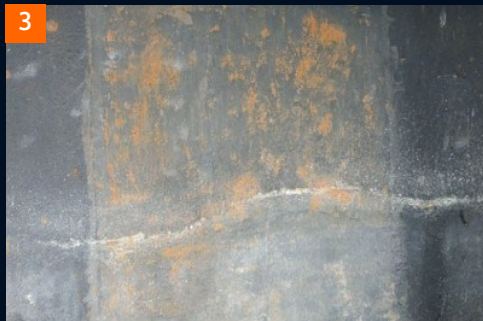
Alternative protective coating blistered during a trial phase.

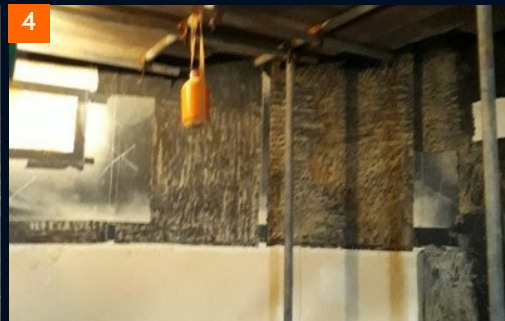
Belzona 1331 - No traces of failure after 8-month trial period.

The client chose to compare three systems simultaneously, over an eight-month period, to assess their performance. The systems selected were: 1. bonding of a rubber lining; 2. using a competitor ceramic coating; 3. using Belzona 1331. The existing rubber lining was removed back to a bare metal substrate before water washing the substrate and blasting to SA 2.5 cleanliness. Subsequently, three coats were applied at 500 microns in accordance with a modified version of Belzona Know-How System Leaflet TCC-3.
