# BELZONA REPAIRS 42 BAR ACTIVE GAS LEAK

ID: 7854

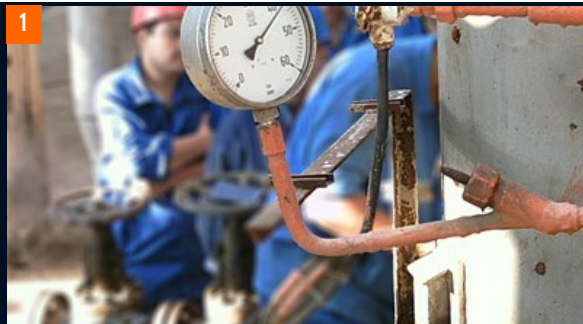
Pressure gauge on pipe showing 42 bar.

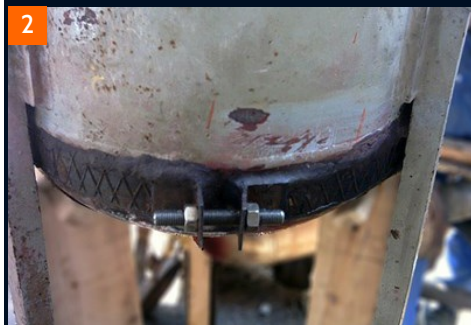
Belzona 9611 clamped down on the repair

Belzona 9611 was applied into the immediate leak area with a clamp to hold it in place during curing. The application was carried out by 7 technicians at the same time due to the limited curing time. The pipe was then reinforced with Belzona 1111 to complete the repair. The application was carried out in accordance with a Belzona Know-How System Leaflet VPF-11.

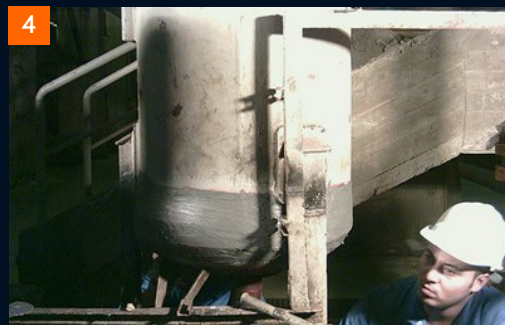
Work Complete
