# BELZONA RESTORES SULPHURIC ACID TANKS

ID: 7855

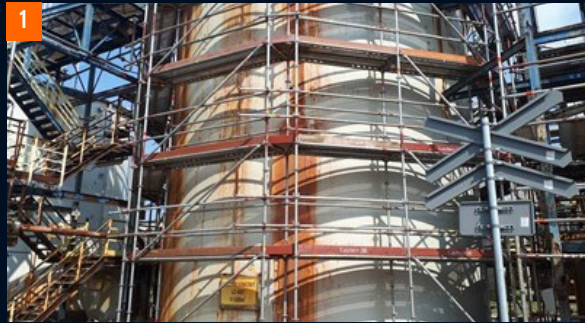
The original state of the tank.

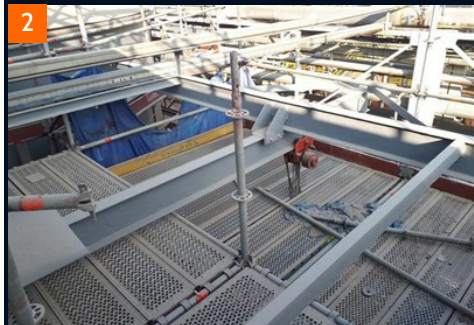
The structure after blasting.

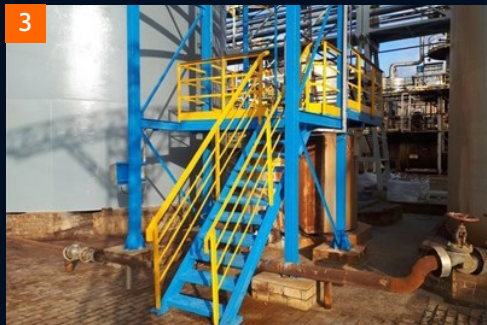
The structure after coating with Belzona 5811 and Belzona 5111.

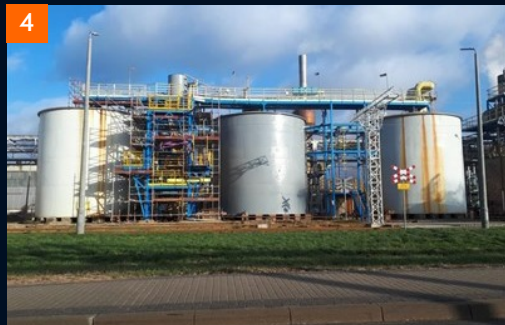
The first completed tank, compared to the unrestored tanks.
