# CHIMNEY RESTORED WITH BELZONA

ID: 7856

Oil refinery chimney, northern Poland

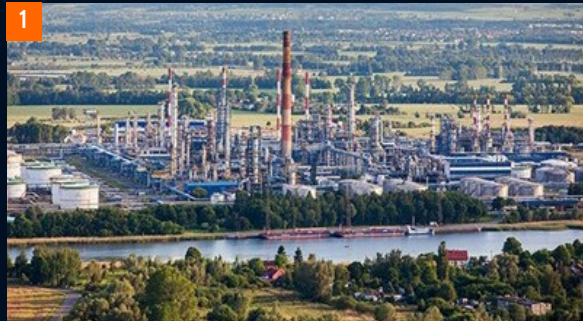
The 120-meter high chimney of the plant's combined heat and power plants required a new more durable coating protection. Previous coatings were very quickly tarnished and damaged.

1. The deteriorated chimney
2. The application underway
3. The completed job
4. The completed job

The application was carried out in Accordance with Belzona System Leaflet FBC-02 The chimney was cleaned, the old paint was removed by abrasive blasting to achieve a good surface profile. Then, Belzona 5911 Ceramic Cladding Conditioner was applied. Two layers of Belzona 5111 (Ceramic Cladding) coating were then applied onto a conditioned surface. The total area to be covered was 4,000 square meters.
