# BELZONA REPAIRS THE SUCTION PART OF A HYDRO TURBINE

ID: 7858

Suction part of a hydro turbine from a hydroelectric plant

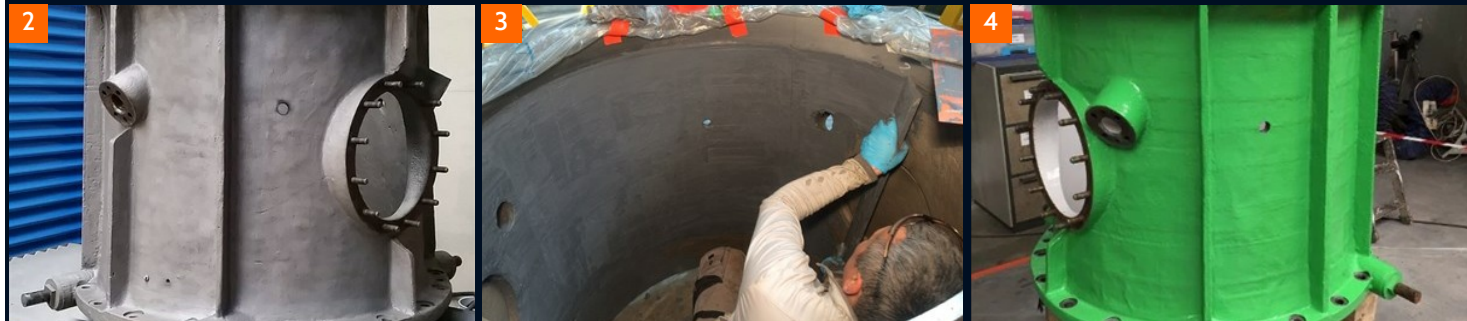
- 1- Before application
- 2- After grit blasting
- 3- Application of Belzona 1311
- 4- After application

The internal surface of this hydro turbine presented an important loss of metal which ultimately led to a hole.

After preparing the surface by grit blasting, the hydraulic profile of the equipment was rebuilt from the inside using Belzona 1311. Two coats of Belzona 1331 were then applied to provide a long-term protection against erosion and corrosion. On the outside of the equipment, patches of SuperWrap were used to recover the mechanical strength of the equipment.
