# BELZONA REPAIRS AND PROTECTS A SAND FILTER AT A NUCLEAR POWER PLANT

ID: 7859

Sand filter in a Nuclear power plant

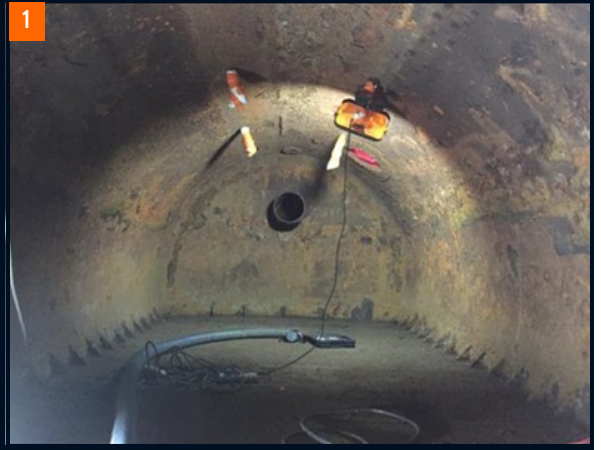
Internal corrosion

- 1- Before application
- 2- Surface aspect before surface preparation
- 3- After surface preparation
- 4- After application

The application was carried out in accordance with Belzona Know How System Leaflet TCC-5. After grit blasting the substrate, it was degreased and the pitting was repaired with Belzona 1111. The surface was then protected with Belzona 1321 to prevent any future corrosion.
