# BELZONA GETS TO GRIPS WITH SAFETY AT AN INTERNATIONAL CONFERENCE CENTRE

ID: 786

Main entrance steps of Conference Centre

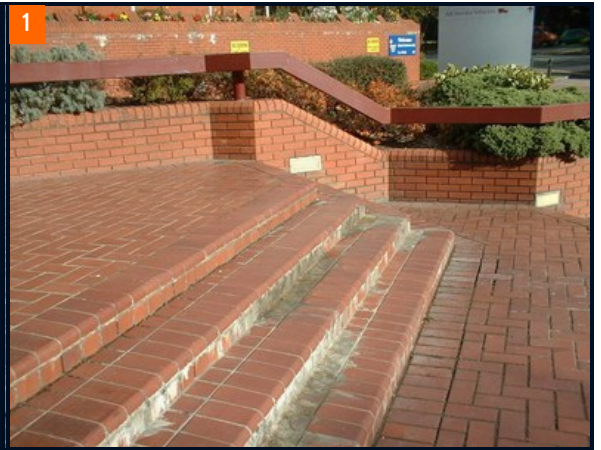
The finish on the tiles which made up the steps was a slip hazard when wet. In addition to this the steps were subjected to heavy foot traffic and misuse by skateboards, necessitating renovation to a condition reflecting the status of the International Conference Centre.

1. Original condition of the entrance steps.
2. Safety Grip areas masked off.
3. The finished application.
4. Application after 6 years of service.
