# BELZONA SAVES A CORRODED AIRTIGHT COMPARTMENT

ID: 7860

Airtight compartment on a shipyard

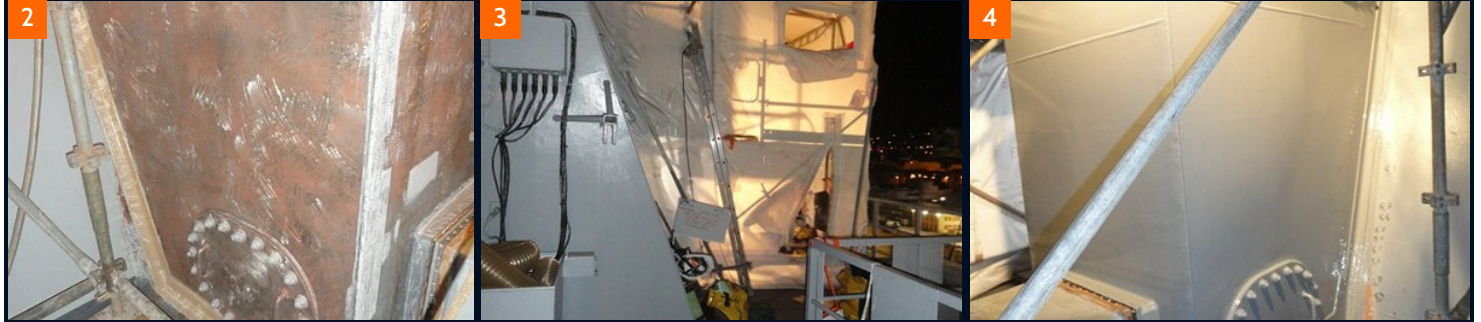
This compartment filled with air and used for underwater works was badly corroded and needed to be repaired and protected.

1- Before application 2- After surface preparation 3- Installation for the application 4- Final result

After carefully preparing the surface by grit blasting, the most damaged parts of the equipment were repaired by bonding metal plates with Belzona 1161. After that, two coats of Belzona 5811 were applied to protect the whole surface against corrosion.
