# BELZONA REPAIRS BALL MILL FOUNDATIONS AT A GOLD MINE

ID: 7862

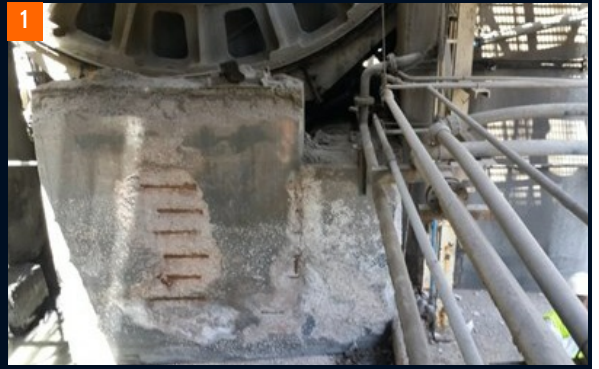
The concrete ball mill foundations degraded over time due to vibrations and warm environment.

1. Before application
2. During the application
3. Final application
4. Overview of the equipment

The substrate was first prepared by grit blasting prior to the installation of steel reinforcement bars. Belzona 4911 was then applied on the whole surface followed by Belzona 4131. The application was carried out in accordance with a modified version of Belzona Know-How System Leaflets FPA-1 and FPA-3.
