# OIL TANK LEAK- POWER PLANT

ID: 7865

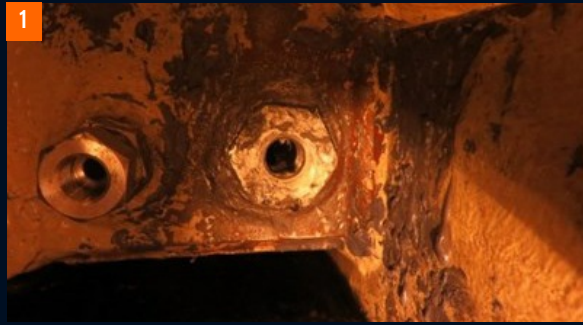
The down deck of the tank had been subjected to severe corrosion leading to drips leak of the oil. This needed to be fixed urgently for the plant to continue operating and also avoid environmental hazards from leaking oil.

1. Oil tank leak area
2. During application of Belzona 1212 to the pinhole on the oil tank
3. Belzona 1212 application completed.

Surface was blasted using Bristle Blaster to remove existing paint and achieve minimum surface profile and cleanliness. Belzona 1212 was applied to seal the leak by cold bonding. Belzona 1212 was re-applied when the first coat reaches its pre-curing time. This application was done overnight because client needed the tank ready in the morning to receive product and thus no plant shutdown.
