# BELZONA SAVES TANK FROM DEMOLITION

ID: 7867

A nuclear power plant's carbon steel holding tank near the sea.

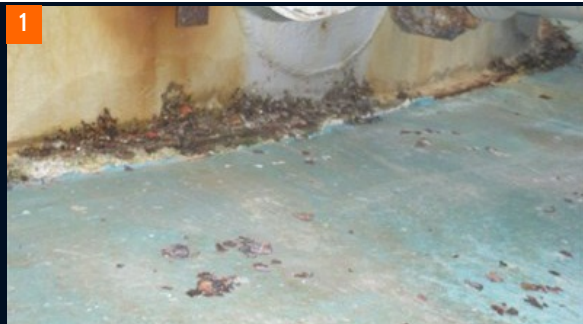
Tank has badly corroded annular plate with suspect under thickness tank base plate due to atmospheric pollutants running down the tank walls and under the plate causing external corrosion. Also, the concrete plinth has cracked and has corrosion causing some spalling.

1. Condition of concrete plinth and tank base
2. Application of Belzona 3111 in grey
3. Corroded flanges
4. Application of Belzona 3412 (Encapsulating Membrane)

The concrete was cleaned. The cracks and defects were rebuilt with Belzona 4111 and Belzona 4911 system. The annular plate was sweep blasted and cleaned prior to applying Belzona 3111 around the tank base in accordance with a modified version of Belzona Know-How System Leaflet GSS-3.
