# CONDENSER RUBBER LINER REPAIRED WITH BELZONA

ID: 7868

Rubber liner of a Steam Condenser

Power plant - Takoradi, Ghana

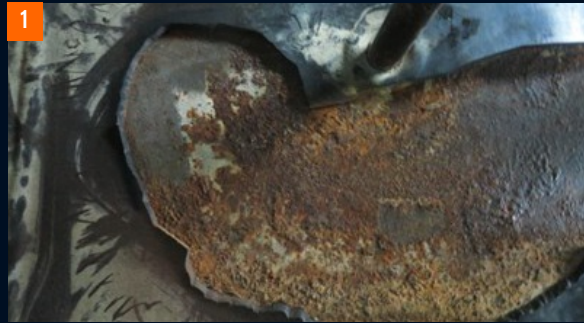
Existing condenser rubber liner peels off and corrosion starts to attack the metallic surface.

1. Before the surface prep and application of Belzona 2111 and Belzona 1111
2. After Surface preparation using bristle blaster
3. After the application of Belzona 1111
4. After view when Belzona 2111 was applied

Application was done in accordance with Belzona System leaflets GSS-1 creating gaskets. After surface was prepared, we notice some amount of metal has been lost. Metallic surface was rebuilt with Belzona 1111. Elastomeric conditioner was applied on the next day, then Belzona 2111 (D&A High-Build Elastomer) was applied, using an applicator and brush.
