# CORRODED WEIGHING BRIDGE REPAIRED AND PROTECTED

ID: 7870

Weighbridge checker plate at a petrochemical plant, LPG/Gas Terminal.

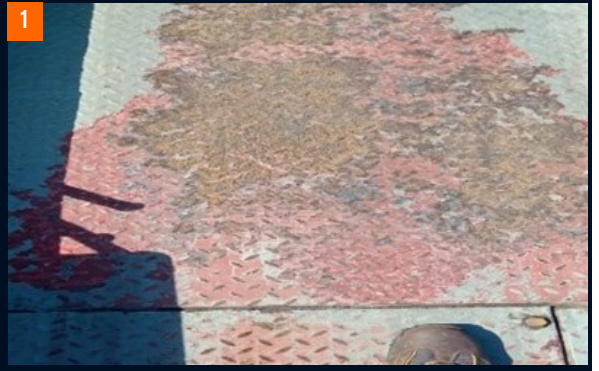
The Customer had an existing weighbridge to determine the amount of Liquefied Petroleum Gas (LPG) leaving the plant on trucks, the corroded weighbridge undermines the accuracy of the data derived from the weighbridge. The worn out surface of the weighbridge was also a safety issue, the Customer has used other surface protection products that failed within a very short period so they opted for Belzona solutions because of the proven durability.

Corroded surface of the weigh bridge  
Original weighbridge.

Application was carried out in accordance with a modified version of Belzona System Leaflet FPA-3 for protecting floors and drains against chemical attack. Belzona 1111 was applied to rebuild the lost metal after surface was blasted with Bristle Blaster. Belzona 5231 was then applied as a heavy-duty protective coating and to protect against further corrosion.

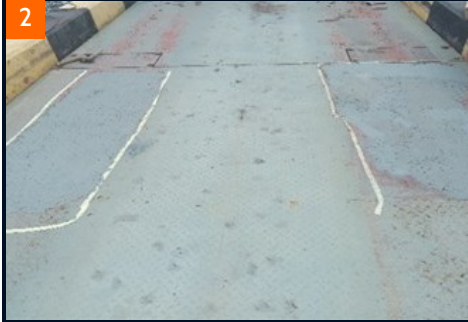
During application on the weighbridge checker plate.

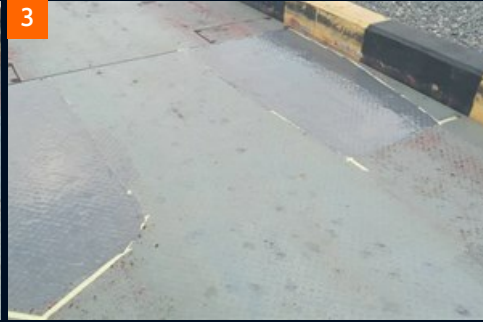
Belzona 1111 being applied to rebuild lost metal.

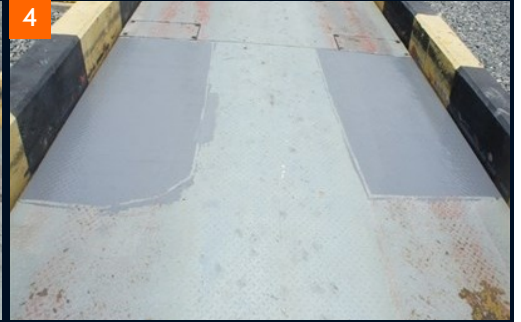
Belzona 5231 being applied to prevent further wear and corrosion.
