# DEWATERING CENTRIFUGE SCROLL REBUILDING AND PROTECTION WITH BELZONA

ID: 7872

A Dewatering Centrifuge Scroll

Wastewater Treatment Plant, Riyadh, Saudi Arabia

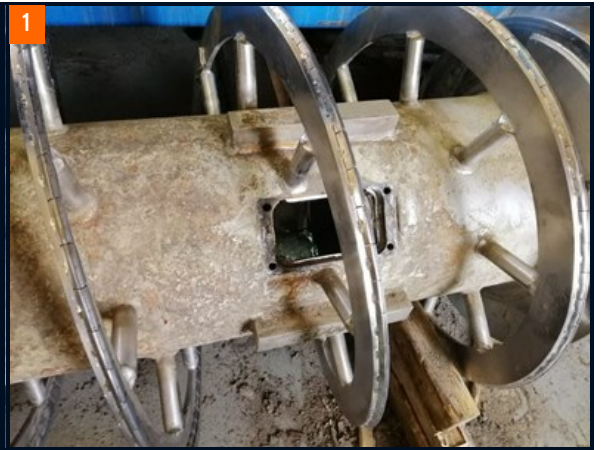
The Dewatering Centrifuge Scroll was damaged and metal chunks were broken due to aggressive wear and abrasion of waste material. All this lead to the client taking it out of service

1. The Dewatering Centrifuge Scroll
2. A close up of the damage
3. Rebuilt with Belzona 1311

In accordance with CEP-1, firstly, the surface was prepared using A3 Grit to get a surface profile of minimum 75 microns. Then, solvent cleaning using MEK. After that, the damaged/abraded surface was filled with Belzona 1311 (Ceramic R-Metal) to level. Finally, Belzona 1812 (Ceramic Carbide) was applied as an abrasion resistant lining to a thickness of 3mm.
