# INTERNAL REFECTION OF A CENTRIFUGAL PUMP USING BELZONA

ID: 7873

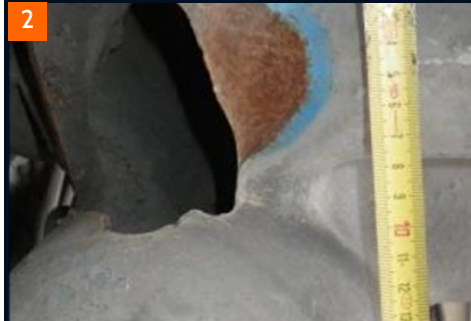
The inside of this pump was badly damaged by entrained solids as it pumps river water. The high speed of the fluid also accelerated the deterioration.

- 1- Overview of the equipment
- 2- Zoom on the main defect on the discharge outlet
- 3- Reinforcement with the metallic net
- 4- Final application

The substrate was first prepared by grit blasting, then Belzona 1111 was used to rebuild the concentric area. It was then machined to get the right tolerances. The discharge outlet was rebuilt from the outside using a metallic mesh and Belzona 1311 and protected with Belzona 1811. Finally the inside of the pump was protected with Belzona 1341.
