# BELZONA REPAIRS GEAR BOX BEARING HOUSING

ID: 7874

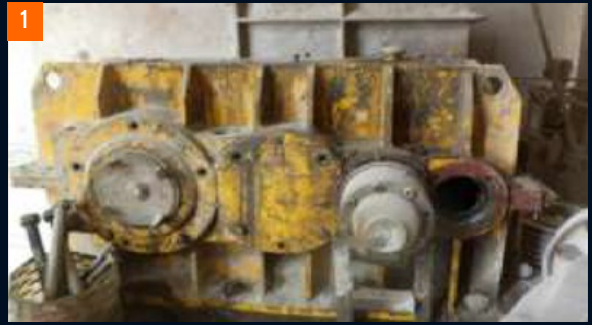
The gearbox.

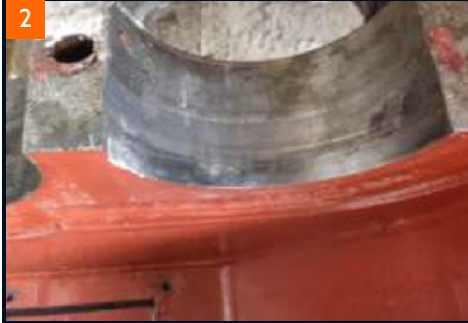
Gear box bearing housing became damaged in-service. Worn-out bearing housing meant that the bearing would no longer sit correctly inside the gear box.

The damaged surface.

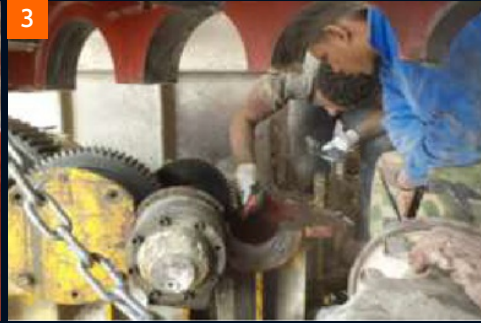
The repair underway.

Application was carried out in accordance with a modified version of Belzona Know-How System Leaflet ENC-03b for rebuilding bearing housing using forming techniques.

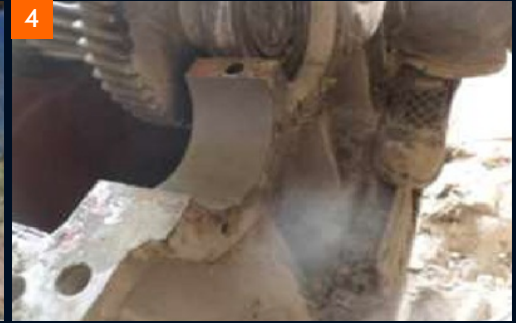
Application completed.

Belzona successfully repaired the bearing housing insitu without machining which would have been difficult due to the large size of the gearbox.
