# GALVANIC CORROSION ON A FLANGE SOLVED BY BELZONA

ID: 7876

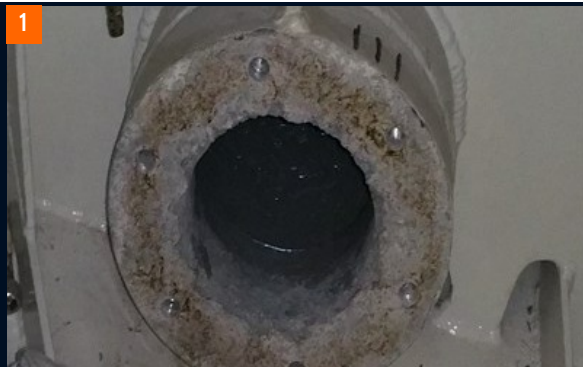
Dissimilar metals were used for the flange connection, leading to galvanic corrosion.

1. Corroded flange.
2. Surface preparation complete.
3. Rebuilding with Belzona 1161.
4. Coated with Belzona 5831.
