# BELZONA PROTECTS 6 PUMP IMPELLERS AGAINST CAVITATION DAMAGE

ID: 7878

6 Centrifugal Pump Impellers at an O&M company.

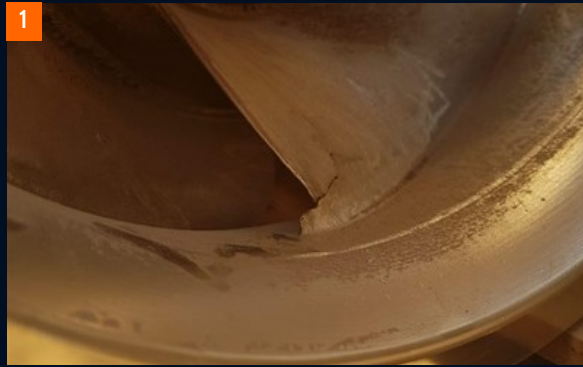
Impeller veins were experiencing cavitation which was reducing wall thickness and leading to through-wall defects.

1. Damage beforehand
2. Application in progress
3. Completed pump

The application was carried out in accordance with a modified version of Belzona Know-How System Leaflet CEP-1, after thorough surface preparation and cleaning, the damaged parts of the impeller were rebuilt with Belzona 1311. Then Belzona 1341 was used to provide protection before Belzona 2141 was applied to protect from cavitation.
