# HOMELAND SECURITY RUSH JOB COMPLETED WITH BELZONA

ID: 788

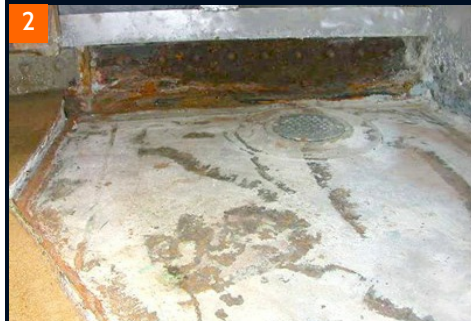
Two old shower stalls on the boat allowed water to seep behind the stall walls rusting a 24" x 4" hole in the deck & leaked water into the engine room. The bulkhead was rusting badly as well

1. The boat
2. One of two problem areas
3. Starting the repair
4. Completed

Belzona® 4111 applied in accordance with Belzona System Leaflet FPA-1 & the new shower base & sides installed in front of the repair while the material was still wet.
