# RUBBER LINED CONDENSER WATER BOX REPAIR REQUIRES BELZONA

ID: 7880

Condenser Water Box

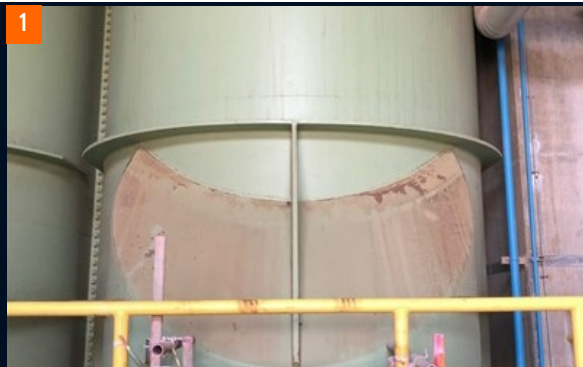
1. Application overview 2. Close up of damage showing erosion and cavitation damage 3. The water box repaired with Belzona 1311 (Ceramic R-Metal)

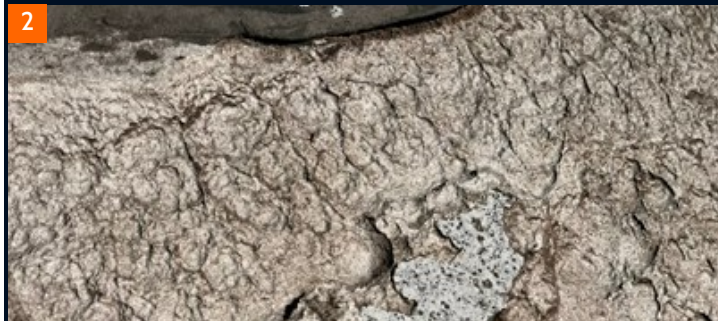
Inspection during the Power Plant shutdown showed severe erosion on the rubber-lined condenser water box, with thickness loss of around 5-6 millimeters in localised areas.
