# BELZONA INTERNAL COATING PROTECTION FOR 3 CONDENSERS AND ABSORBERS

ID: 7881

3 Condensers and Absorbers

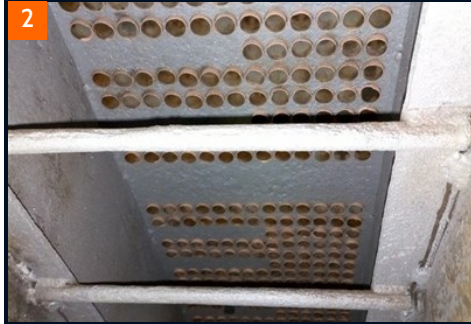
Tube sheets, water boxes and end covers were subject to high erosion-corrosion. As a result of galvanic corrosion and chemical attack, they were severely corroded.

1. A condenser and absorber before
2. Application in progress
3. The completed application
4. Close up of the completed application

The application was carried out in accordance with Belzona Know-How System Leaflets HEX-1 and HEX-3. After grit blasting, erosion damage & pitting were rebuilt, prior to applying Belzona 1391T for overall corrosion and chemical attack protection.
