# BELZONA REPAIR AN ENGINE CASING OF A LUXURY CAR

ID: 7882

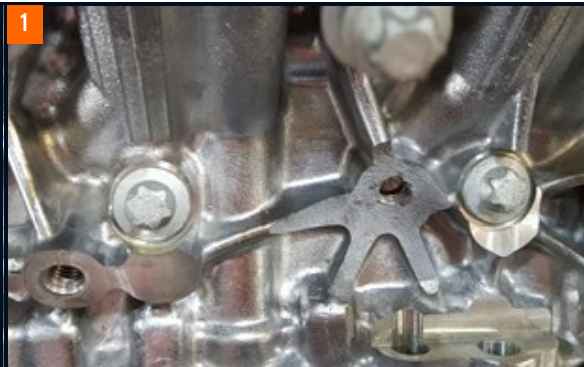
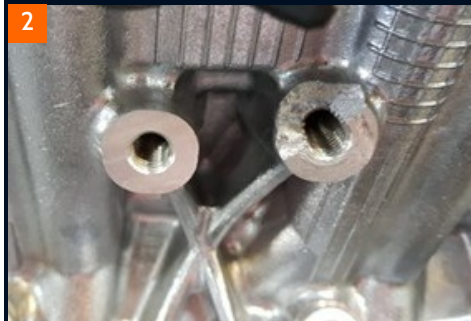
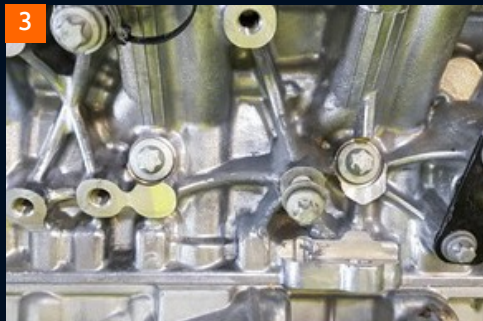
Several mounting bracket sets were cracked and broken. The customer wanted to achieve a perfect finish for both strength and aesthetic point of view. Belzona was chosen as an alternative to welding.

The engine casing was damaged due to a car crash.

1 - 3 Damaged engine mounting bracket sets

The application was carried in accordance with modified versions of Belzona Know-How System Leaflets ENC-1 and ENC-2.

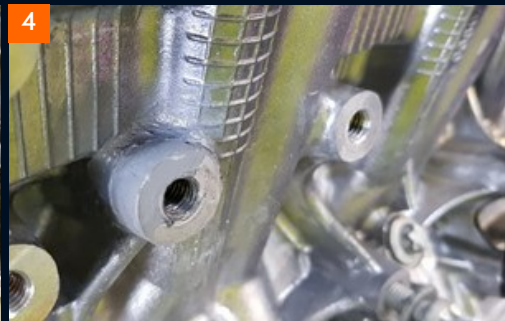
4. Completed repair
