# BELZONA REPAIRS EXPANSION BELLOW AT A POWER PLANT

ID: 7883

Expansion Bellows at a large fossil fuel-fired power plant.

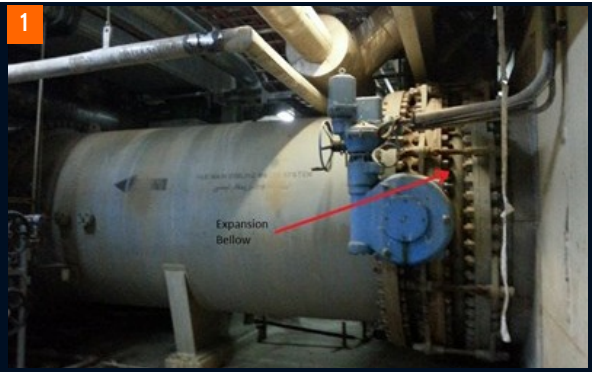
The expansion bellows were in critical condition where layers of the rubber were disbanded and accumulating. These were blocking the tubes at inlet section of the condenser and ultimately reducing its efficiency.

1. Expansion bellows in operation.
2. The bellows prepared for the repair.
3. The application of Belzona 2211.
4. Repaired bellows.
