# BELZONA EXPANDS THE LIFE OF EXPANSION JOINTS

ID: 7884

34 inch expansion joints on a 25-year-old pipeline

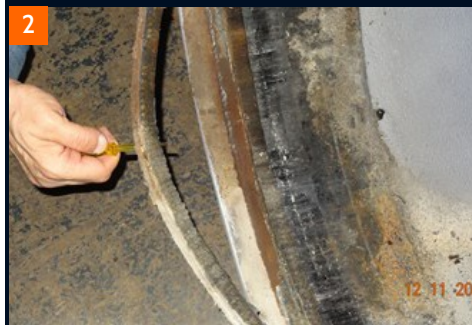
After restarting following a shut down, expansion joints in the flare header started leaking, forcing the plant to shut down under an emergency situation.

1. The expansion joints taken out of operation
2. The damage before
3. Application in progress
4. Completed application

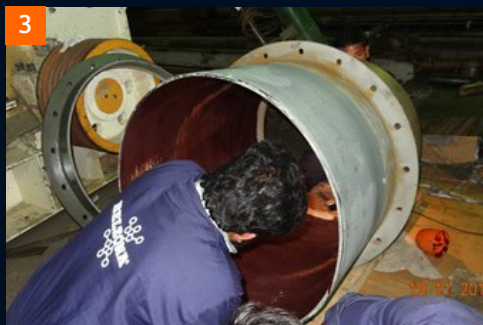
The internal of the Expansion joints had not been inspected and the internal conditions were not known. The customer had no drawings / technical specifications with respect to gaskets. However, there was also a very short lead time for repairing the six expansion joints. All the six expansion joints were tested for "Zero leakage" and were installed back to the flare header with the full satisfaction of the customer. All the six expansion joints are working fine to date, without any leaks.

The application was carried out in accordance with system leaflet MPT-06. Belzona 4301 (Magma CR1 H-Build) was used for the rebuilding of seating faces/pitting damages. Belzona 4311 (Magma CR1) was used as the internal coating of the expansion joints.
