# BELZONA OFFERS A PEACE OF MIND TO A PRIVATE VILLA OWNER

ID: 7886

Five underground potable water storage tanks within a luxury villa.

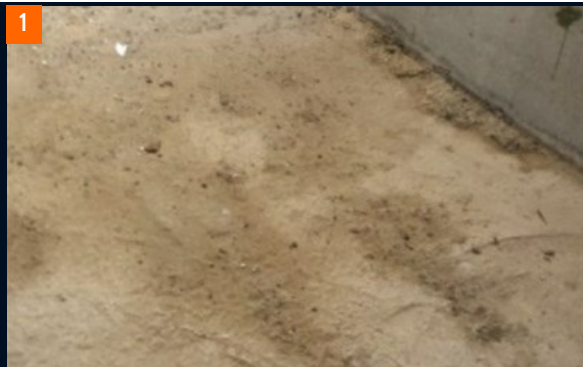
Poorly finished concrete walls and floors.

1. The potable water tank before the application.
2. Another view of a tank before the application.
3. Complete application.

The application was carried out in accordance with a modified version of Belzona Know-How System Leaflet FPA-1, Belzona 4111 was used to repair the poorly finished concrete walls and floors of the tanks and Belzona 5891 was used to coat the internal surfaces of the tanks.
