# BELZONA COATS SIX CHILLERS AT AN AIRPORT

ID: 7889

6 chillers at an international airport.

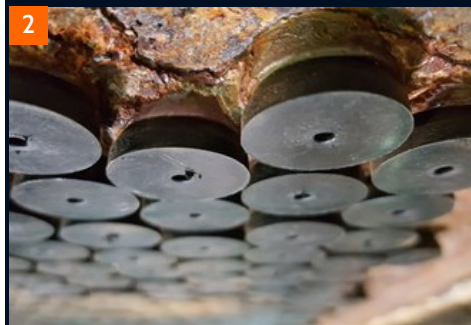
Maintenance service of an International airport experienced problem with six chillers that covered all cooling needs for the entire facility. All units were in service for the period from 5 to 10 years and suffered from extensive corrosion on covers and water boxes, that also led to gas losses and leaks through tube sheets on two units out of six.

1. One of the units in its original state
2. Rubber corks inserted before blasting on a heavy corroded tubesheet
3. Application of the Belzona system
4. Complete repair and a final coat of Belzona 1331

Rubber corks were used at the first stage to protect internals of copper pipes from abrasive cleaning and on the second stage preformed as molds for the Belzona 1111/1331 system. The system was under force vacuum before applying Belzona products in order to seal the gas leaks, an injection pistol was used to make sure the deep gaps between the pipes are completely filled with product.
