# REPAIR OF CONCRETE SUPPORT FOR EFFLUENT VESSEL

ID: 7890

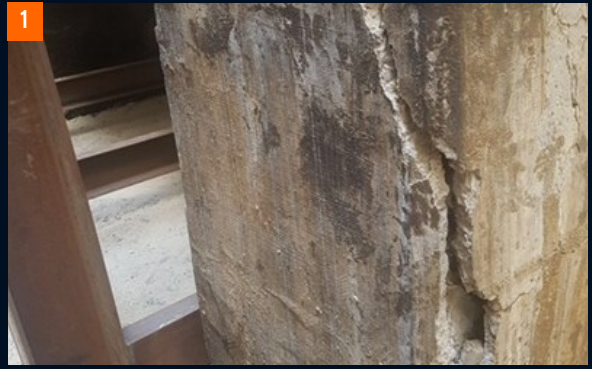
Damaged Concrete Supports of effluent water vessel: Water ingress and weathering had caused corrosion of the reinforcement bar leading to cracking and spalling of the concrete supports.

1. Before application
2. damaged and loose concrete was removed.
3. Finished application
