# BELZONA REPAIRS A CHASSIS ON AN AIR-COOLING SYSTEM

ID: 7894

Chassis of a gear reducer on an air-cooling system in a nuclear power plant.

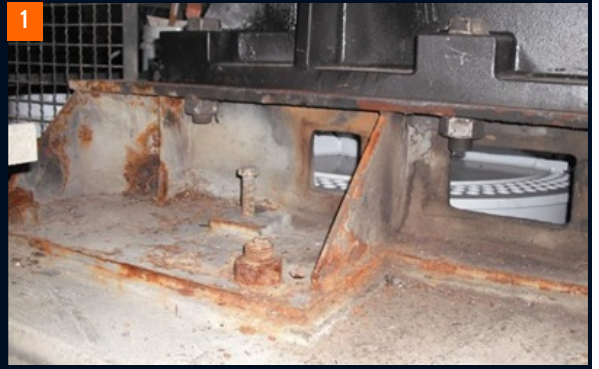
The water circulating in this equipment was treated with CO<sub>2</sub> and other additives against legionella causing an important problem of corrosion.

- 1- Before surface preparation
- 2- After surface preparation
- 3- Overview of the air-cooling equipment
- 4- Final application

Application was carried out in accordance with an adapted version of Belzona System Leaflet FBC-2. The substrate was first prepared with a needle gun and grit blasted. Then, one coat of Belzona 5831 was applied (600microns).
