# BELZONA REPAIRS AND PROTECTS AN SEC PUMP

ID: 7895

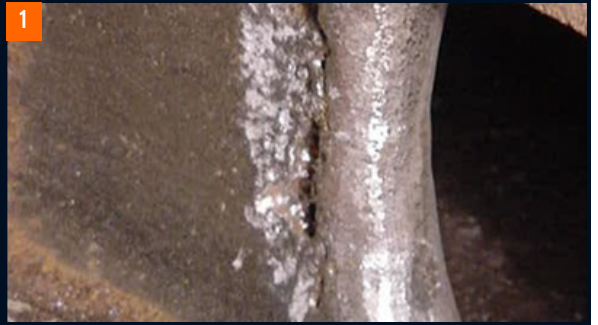
1- Before application

The cut-water of this pump was damaged by erosion/cavitation and needed to be rebuilt and protected.

The rebuilding step was done with Belzona 1311 in accordance to Belzona System Leaflet CEP-1. The area was then protected by overcoating with Belzona 1341.
