# BELZONA EXTENDS THE LIFE OF A CRF WHEEL

ID: 7896

Blades on a CRF wheel in a nuclear power plant.

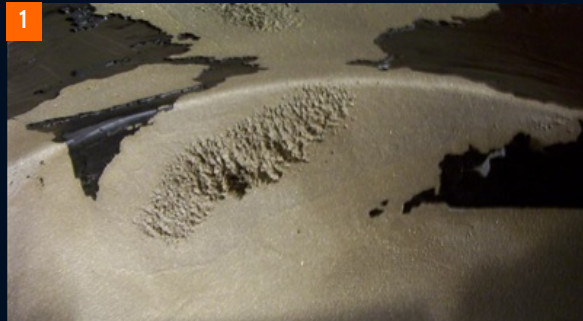
1- Before application

The coating and the equipment were damaged by cavitation.
