# BELZONA REPAIRS AND PROTECTS A CONCRETE PUMP VOLUTE ON A WATER COOLING SYSTEM

ID: 7897

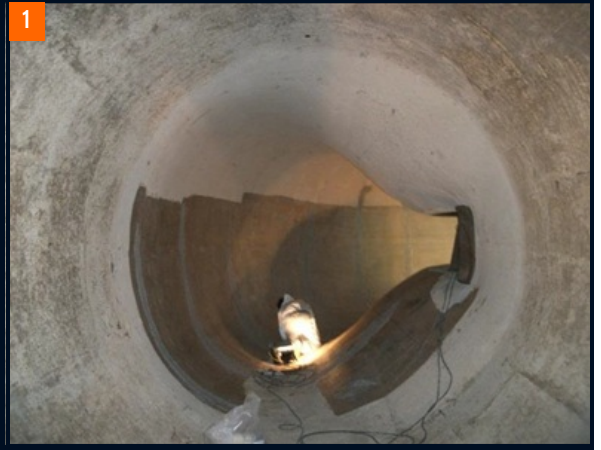
1- After the surface preparation, conditioner application

Application was carried out with an adapted version of Belzona System Leaflet FPA-01. After the surface preparation, the conditioner was applied and Belzona 4111 was used to rebuild the damaged area especially around the cutwater and all around the volute. Then, Belzona 1321 was used to protect the walls against erosion/corrosion.

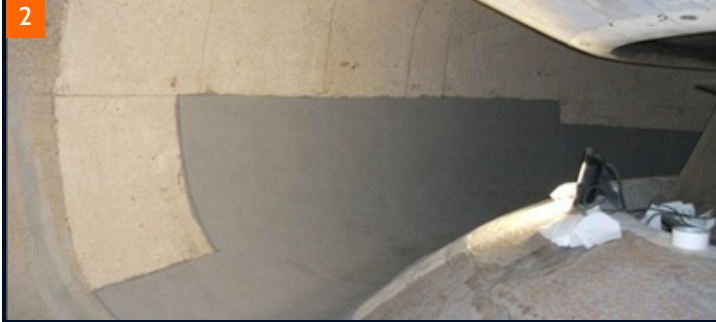
2- Application of Belzona 4111

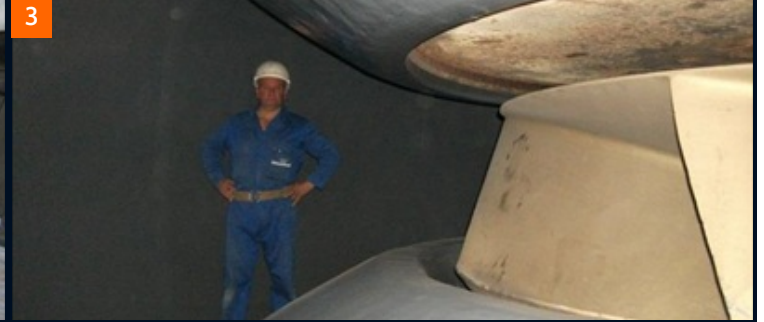
3- Final application
