# BELZONA REPAIRS A VACUUM PUMP CASING AND PROTECTS IT AGAINST CAVITATION

ID: 7899

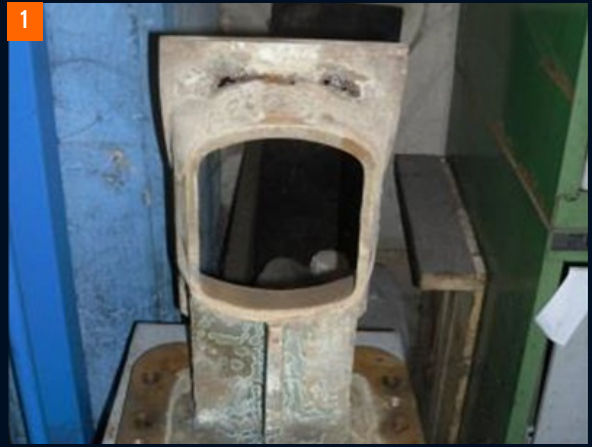
1- Overview of the equipment

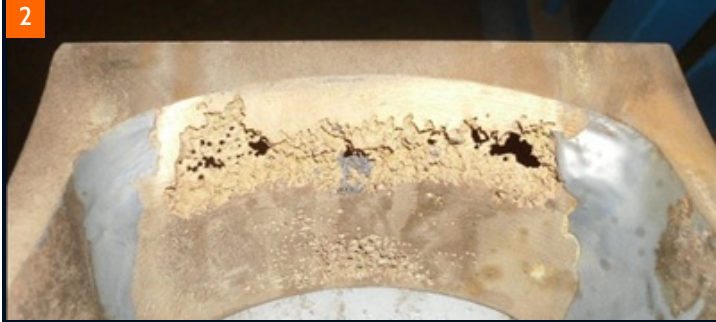
The casing of this pump was exposed to a severe cavitation causing important damages and perforations after only a few months.

2- Zoom on the damages

Belzona 2311 was first used to rebuild the damaged area, then Belzona 2141 was used to protect the whole application against cavitation.

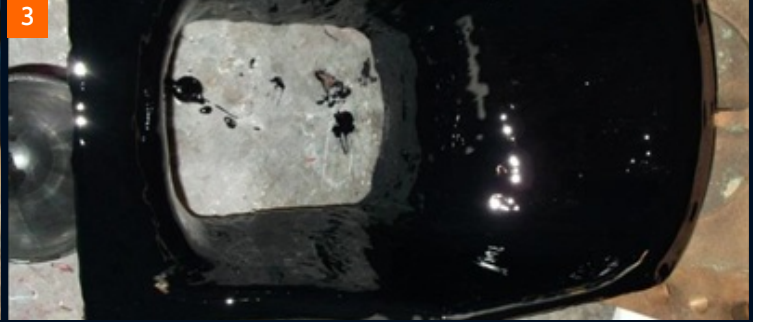
3- Final application
