# BELZONA MATERIALS RECONDITION AIR CONDITIONER

H.V.A.C. tube sheet repair

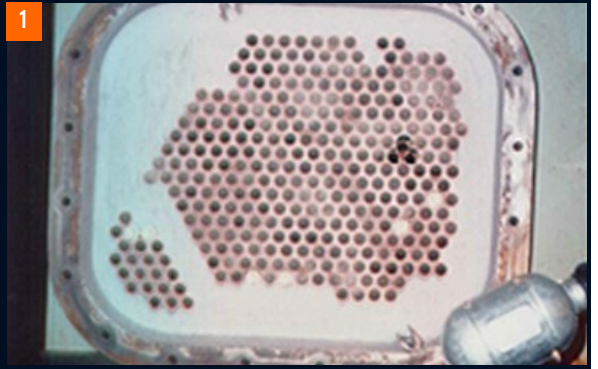
The tube sheet had suffered erosion/corrosion damage to the extent that three tubes no longer made contact with the sheet.

1. Original condition of the tube sheet showing three tubes not in contact with the sheet
2. Tube sheet surface being prepared
3. The sheet, restored to full working order
