# BELZONA REBUILDS AND PROTECTS A SULPHURIC ACID TANK

ID: 7900

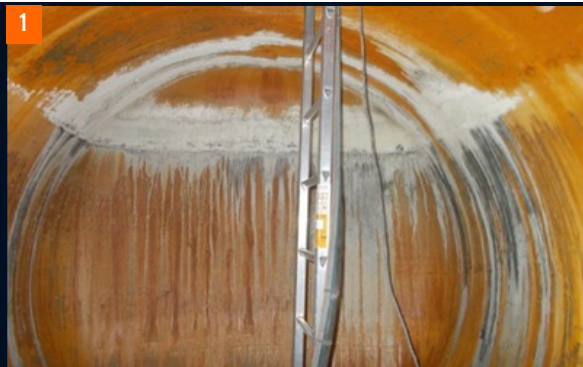
Due to the high concentration of sulphuric acid contained in this storage tank (98%), the walls were severely corroded, causing an unn loss of thickness.

1. Before surface preparation
2. After surface preparation
3. Final application
4. Final application

The inside of the tank was first grit blasted, then Belzona 1121 was used to recover the loss of thickness. Then Belzona 4311 was used to protect the whole internal surface of the tank against sulphuric acid. This application was carried out in accordance with a modified version of Belzona Kow-How System Leaflet TCC-05.
