# BELZONA INSTALLS A NEW DRAIN NOZZLE ON A PHOSPHORIC ACID STORAGE TANK

ID: 7908

Drain nozzle on a 54% phosphoric acid storage tank.

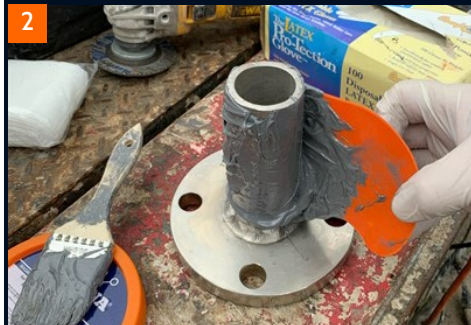
The drain nozzle broke off a tank that stores phosphoric acid.

1. Broken off nozzle.
2. Applying Belzona 4301 to the new nozzle
3. The new nozzle inserted
4. Complete application
