# SPLIT PUMP KEEPS IT COOL WITH BELZONA

ID: 7910

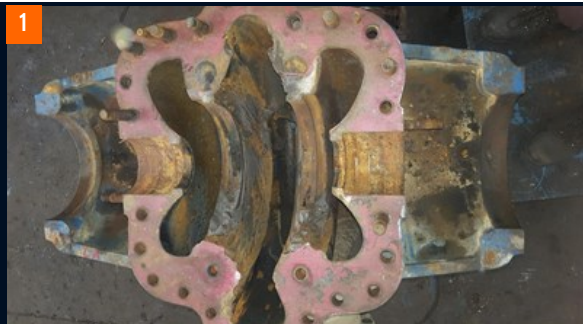
Heavy erosion caused by suspended particles in the fluid.

10 years after Belzona 1321 was applied to the split case pump, the coating is now almost completely gone and erosion has removed some of the steel. The customer was happy with the performance of Belzona and wished to utilize Belzona materials to further extend the life of this pump.

1. Pump after 10 years in service (some Belzona 1321 still visible)

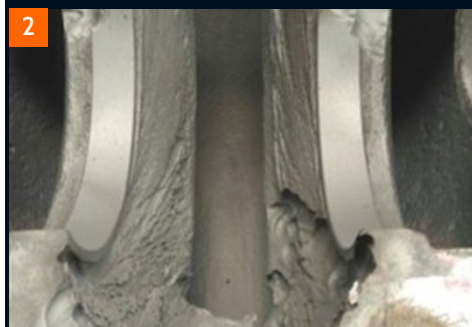
2. Wear ring seating areas rebuild with Belzona 1311

The application was carried out in accordance with Belzona System Leaflets CEP-2, CEP-3 & CEP-5.

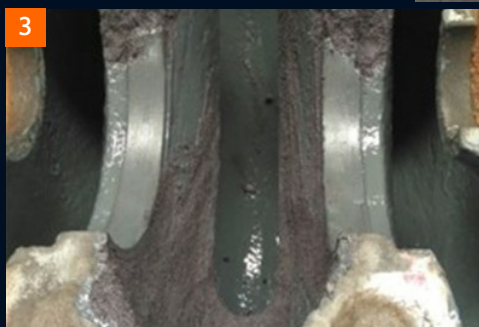
3. Most severely worn areas rebuild and protected with Belzona 1812

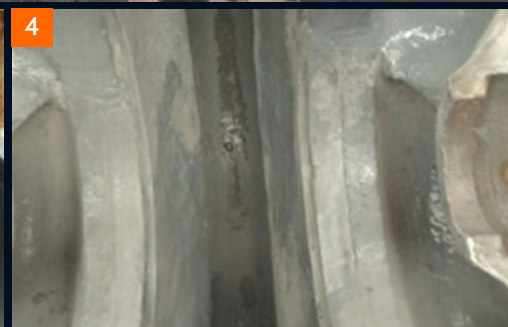
4. Remaining areas rebuild with Belzona 1311 & coated with Belzona 1321
