# BELZONA HAS WHAT IT TAKES TO STOP THE ACID LEAK

ID: 7911

In a Copper production acid plant, pipework in a gas washing process carries acid contaminated gases.

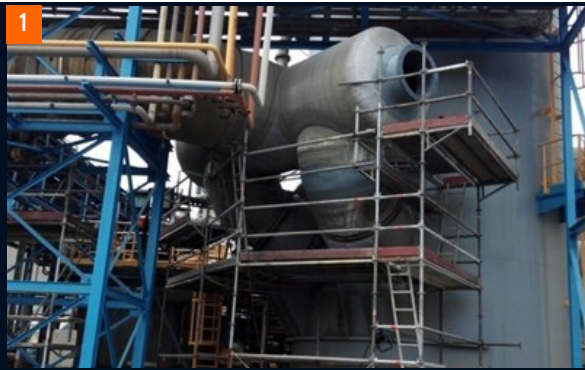
1. Location of equipment within the acid plant
2. Close up of defect
3. Belzona 4301 being applied
4. Completed repair

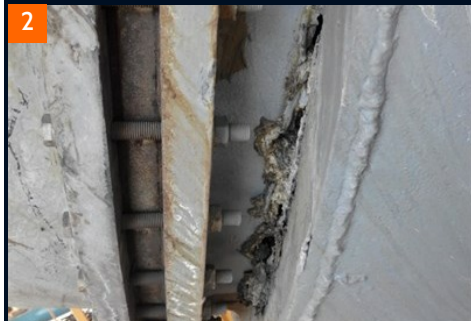
In the gas suction line condensation of the acids on the internal surface has caused severe corrosion, leading to leaks, which are hazardous to the surrounding environment.

The damage is localized to a small area on a large section of pipework. Replacing is a costly and work intensive exercise. Weld repairs are likely to lead to the same problem occurring again. Access for heavy welding equipment is also difficult, and hot work is not permitted without special measures being put in place, which are undesirable to the customer. Belzona 4301 has the required chemical resistance to stand up to the 98% sulfuric acid, and can be applied quickly and easily, making it a convenient and effective solution.
